# iSimangaliso

## iSimangaliso – Lake St Lucia changing with time

*Newsflash No.: 2018.02.12*

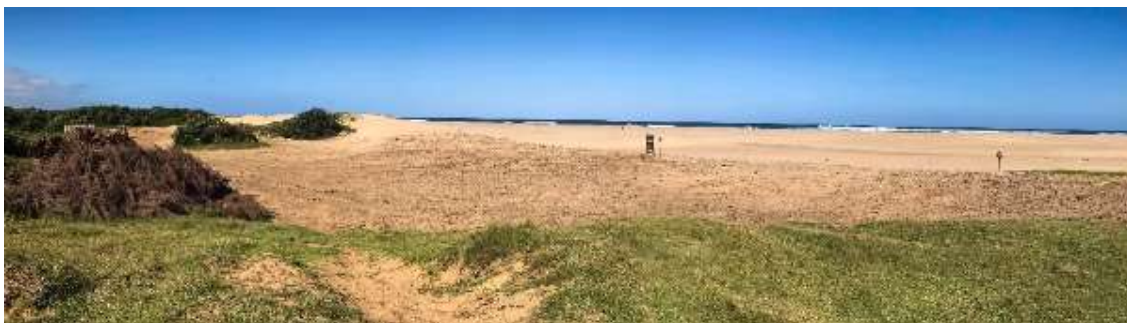
*The northern end of the sand barrier after removal of the toilet block and casuarinas created a fantastic wide open vista towards Maphelane*

Says Forbes, "Restoration of the estuary has continued since the completion of the major intervention, which was to remove dredge spoil between the uMfolozi River and the estuary, with the decommissioning of the Estuary car park and removal of the toilet block. This was done in recognition of and as preparation for the dynamic nature of the estuary mouth as it settles into its original configuration."

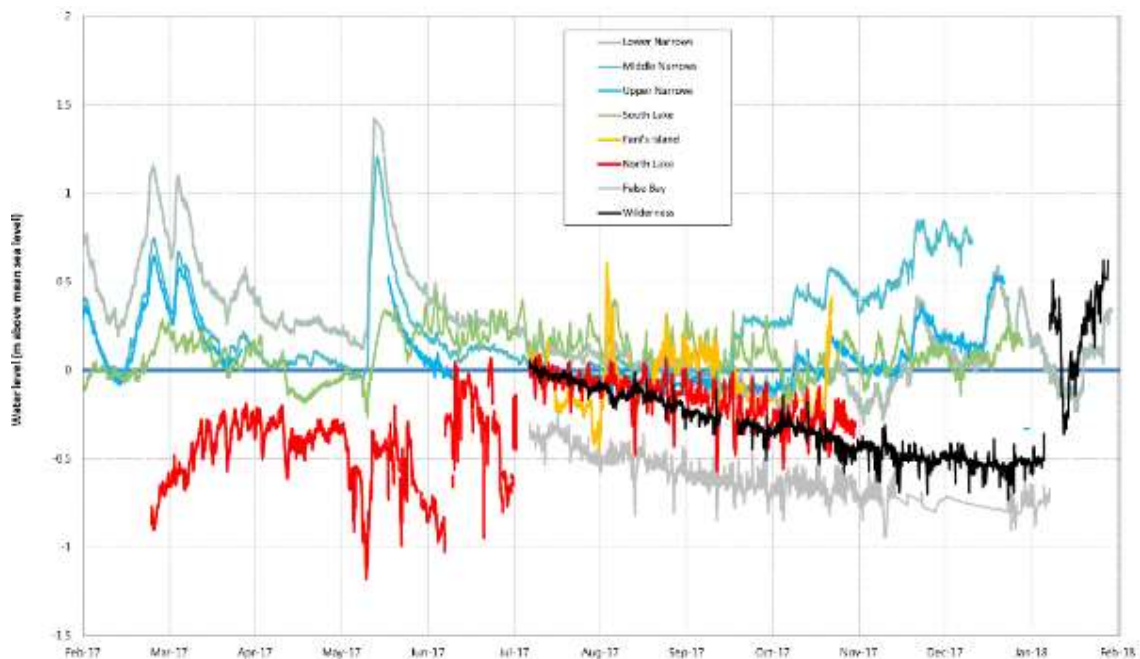
Water levels are measured at various stations within the estuary and are included in the plot below. Water in the Narrows is above Mean Sea Level and the higher levels in the Narrows have supplemented the southern lake levels. Despite the dryness of winter, some shallow water even remained in the northern parts of the estuary with North Lake, False Bay and the Wilderness water quality stations all registering some water depth.

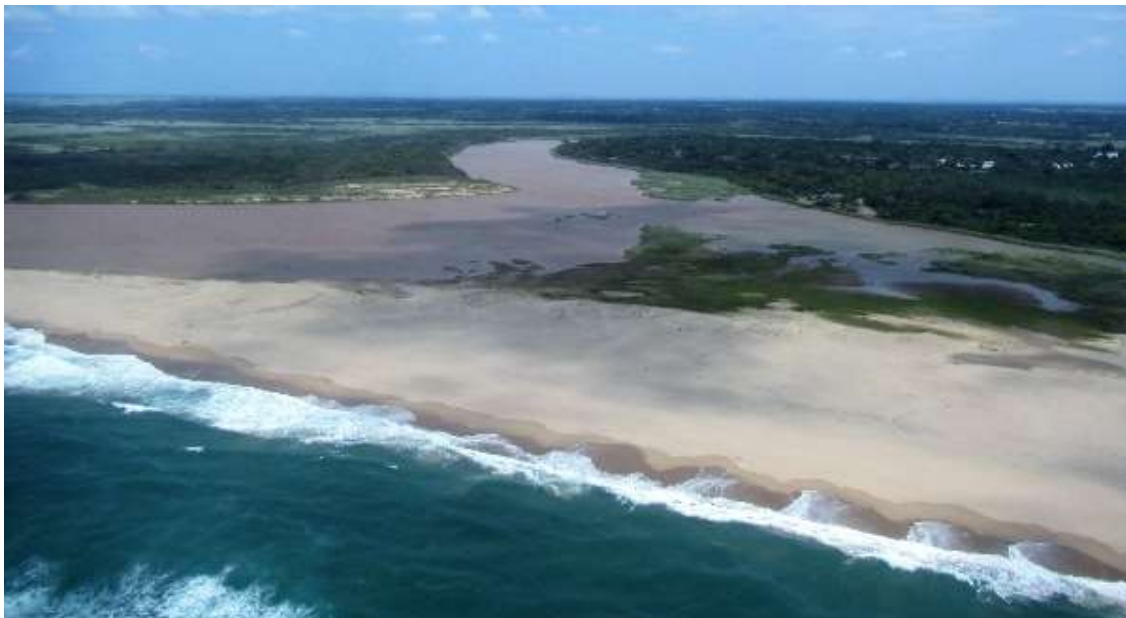
*Researcher Bruce Mann took this aerial photograph of the Lake St Lucia mouth area in January 2018.*

The mouth of the estuary has remained closed since October 2014. Since then a number of over-washing events have occurred with the influence of the sea being clearly seen in the real time monitoring data showing as increases in salinity moving through the Narrows and even into Catalina Bay. Says Forbes, “What is really needed now is a strong freshwater pulse from the uMfolozi of a volume large enough to overtop the sand barrier or flow with enough velocity to break through and begin the process of establishing a new mouth.”

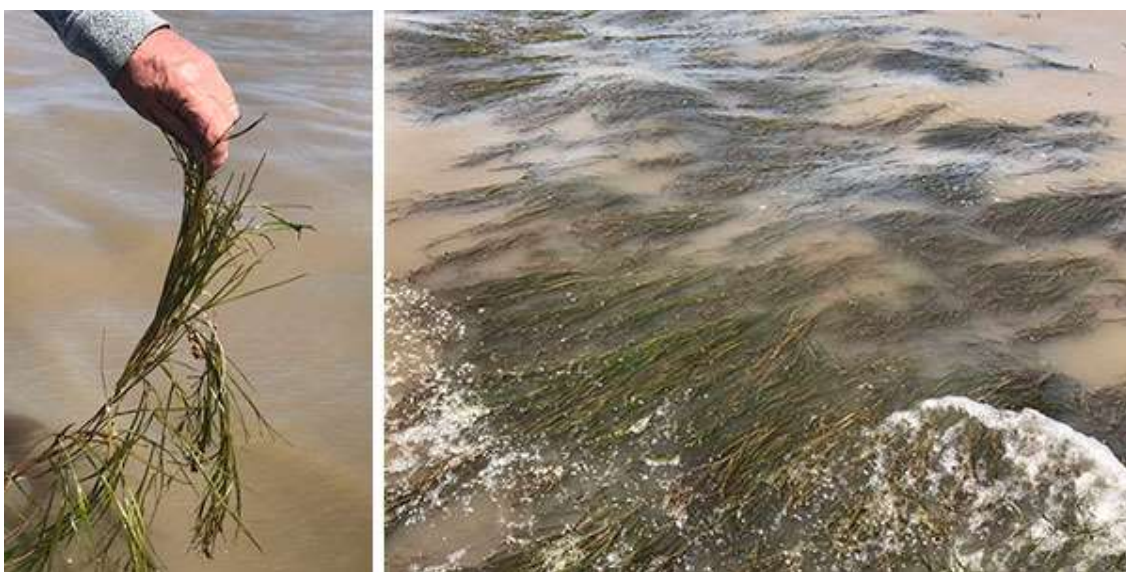
*Submerged aquatic plant, Stuckenia pectinata in South Lake*

Large areas of South Lake and to a lesser extent Fani’s Island area had been colonised by the submerged aquatic plant, *Stuckenia pectinata*. This plant thrives in stable water conditions with salinities below 20. These macrophytes in turn will support large numbers of epiphytic algae and at times other invertebrate fauna and in this way create important feeding and shelter habitats for a wide variety of

juvenile fish. Its presence and abundance in the estuary during December 2017 indicated the sustained presence of water in the upper estuary.
